STATE OF VERMONT
AGENCY OF TRANSPORTATION

Scoping Report

Hartford IM 091-2(79)
I-91, Bridge 43N & 43S over US 5

January 29, 2013

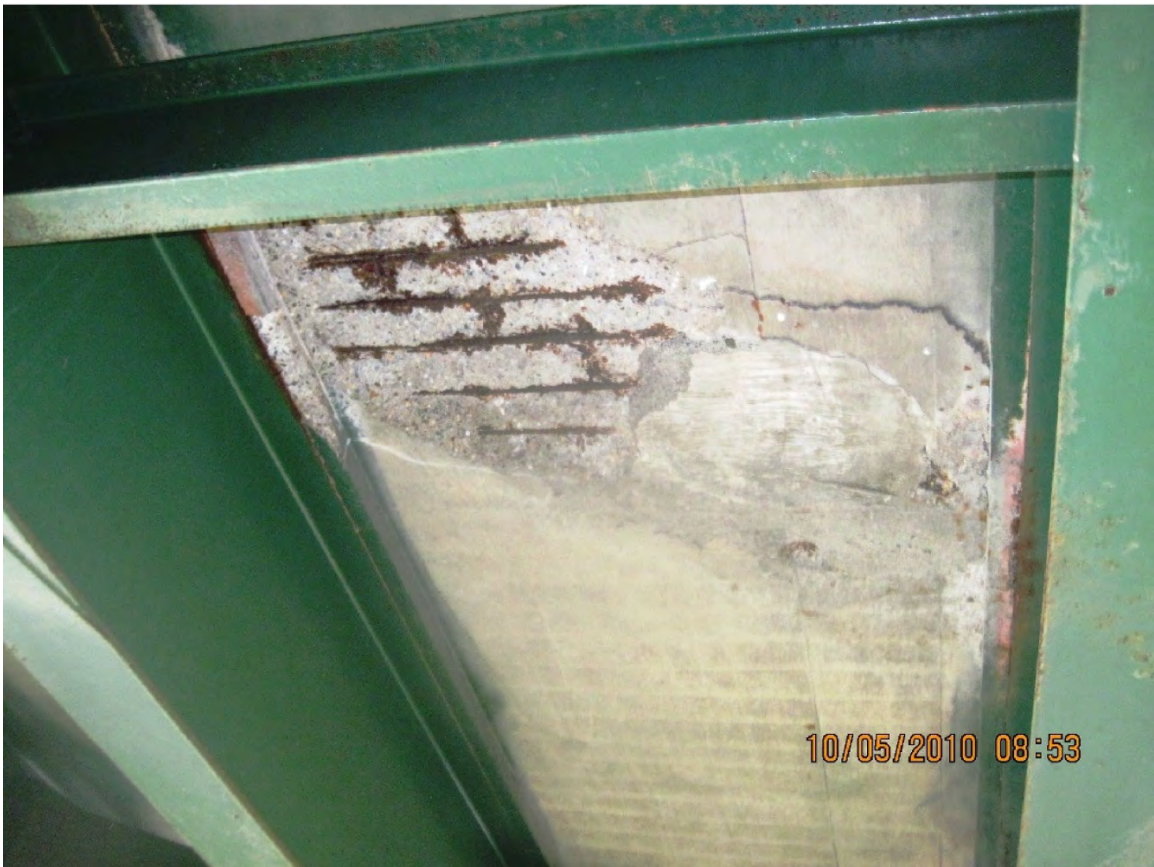
Extensive sections of the fascia along with localized delaminations on interior portions of the deck on Bridge 43 N could use repair. The quantity of deck patching or replacement required on 43 N is approaching the threshold where a complete deck replacement would be more cost-effective. Bridge 43 S, on the other hand, is in relatively good shape and could be maintained with relatively minor patching at this time.

Localized Deck Deterioration

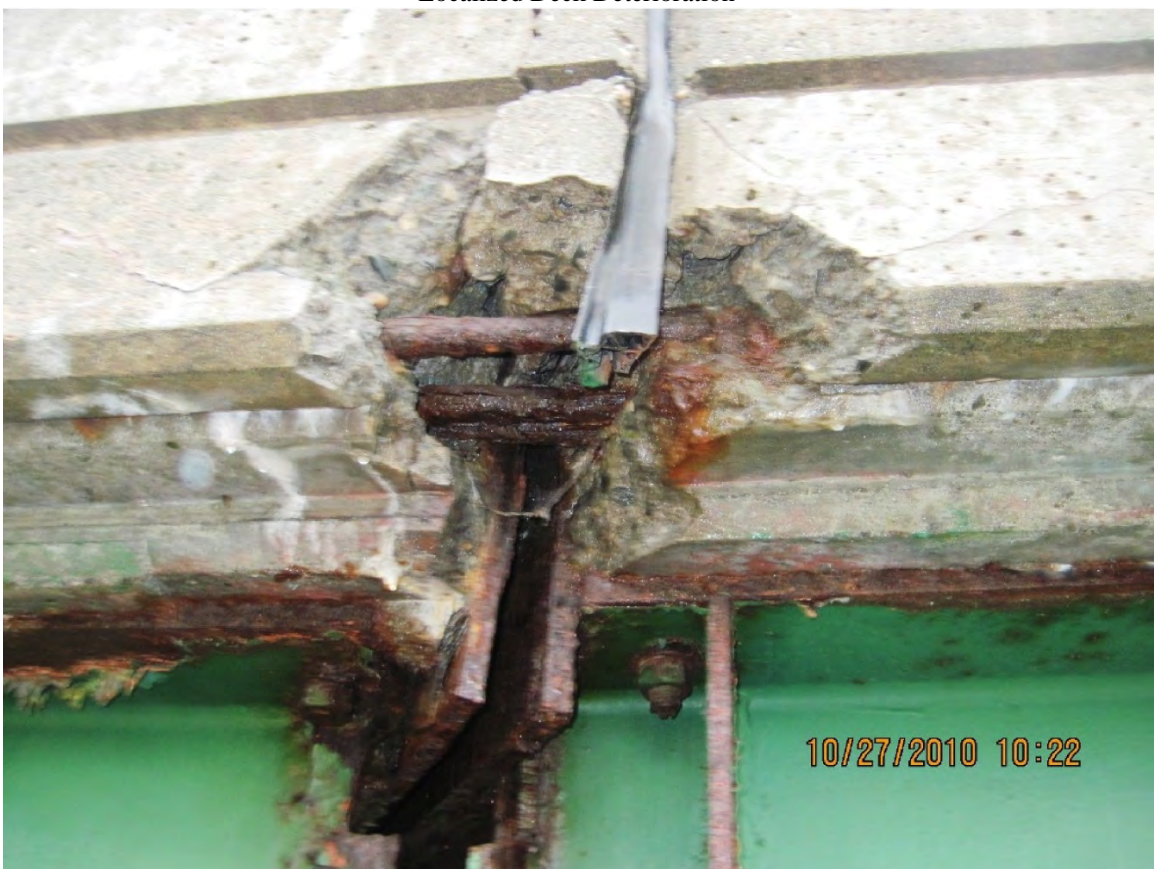
(43 N) 4/25/12 The trough under the finger plate joint needs to be replaced. The beams need extensive cleaning and painting. The joint areas continue to leak along the east end onto the suspended beam seat areas, allowing for continued section loss, especially in beam 6. Immediate attention is needed not only to prevent/repair the deterioration of the beams but also to prevent further spalling around the joint areas. The broken anchor bolts in beams 3 and 4 along pier 2 need to be repaired. JWW

Joint Deterioration

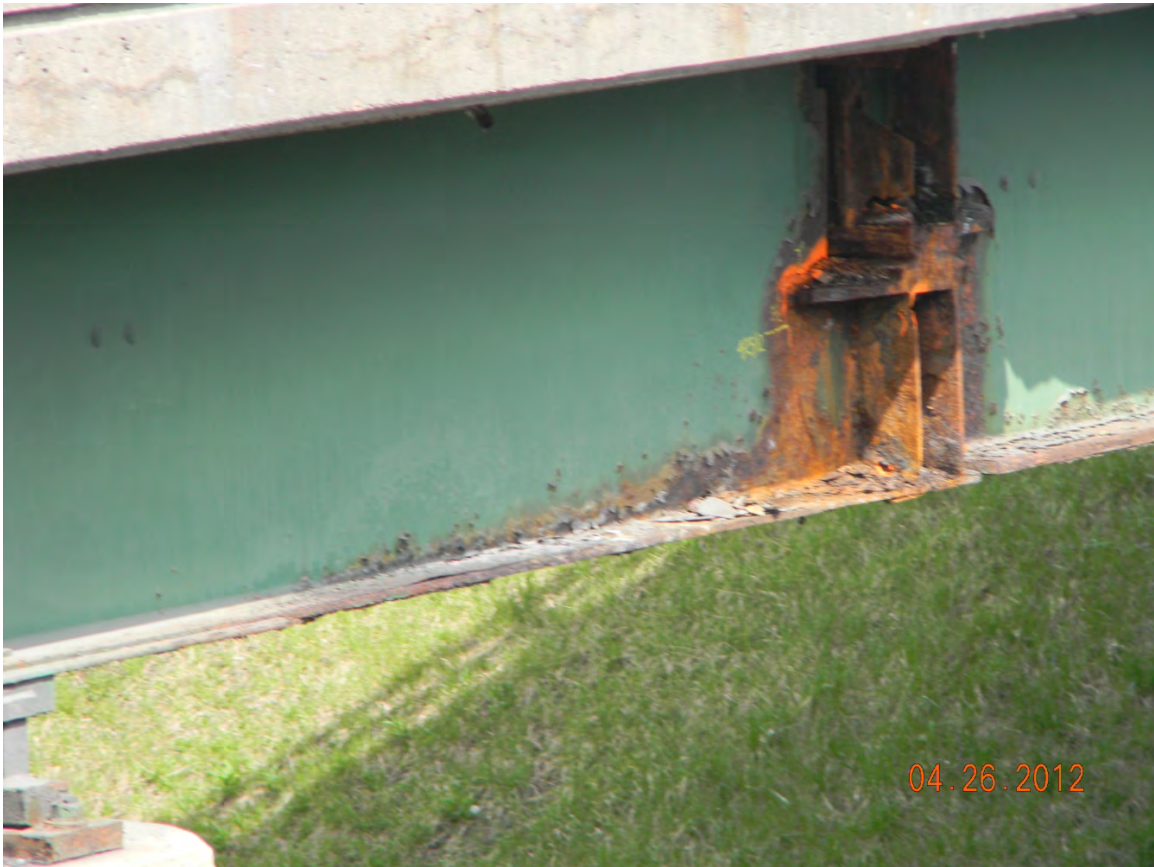
Cracking around Beam Support

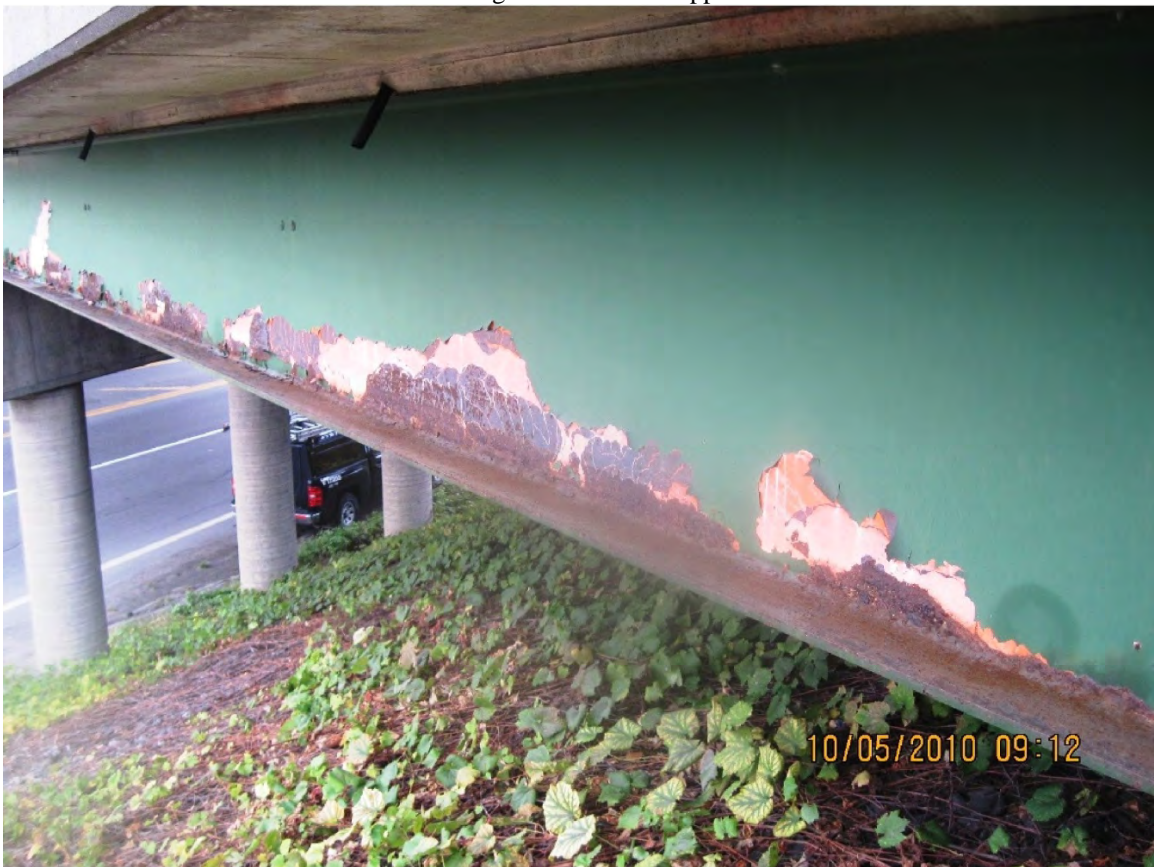
Both of the structural steel retrofit options have some disadvantages. Once the beam ends have been addressed, the remaining steel still needs to be cleaned and painted. Cleaning and painting the existing steel in place would need to be done in phases while the traffic on US 5 is shifted from side to side to keep the painters a safe distance away from the vehicles. After one adds the cleaning, painting and containment costs to the contract, it becomes reasonable to consider replacing the steel beams rather than rehabilitating them. There is no good way to replace steel beams while preserving the existing concrete deck, and on Bridge 43 N, the deck has deteriorated to a point where one would not want to keep the existing deck anyway. Thus, if one is replacing the steel beams to rectify the fatigue and painting issues, the entire superstructure should be considered for replacement.

Paint Deterioration

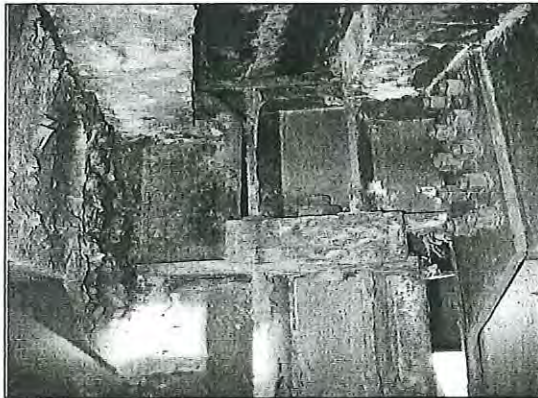
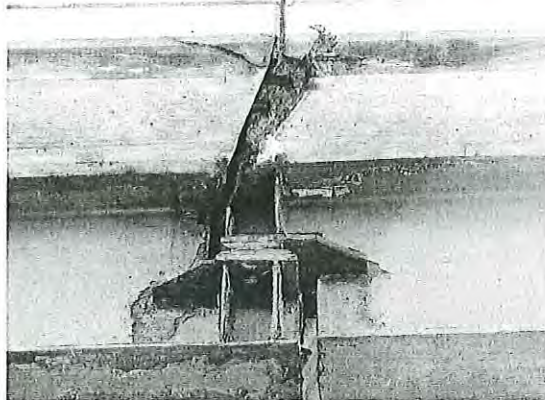
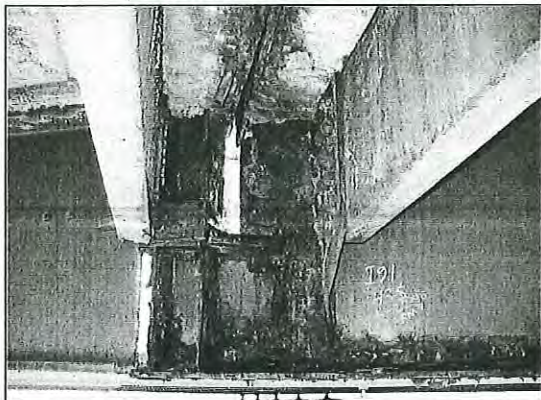
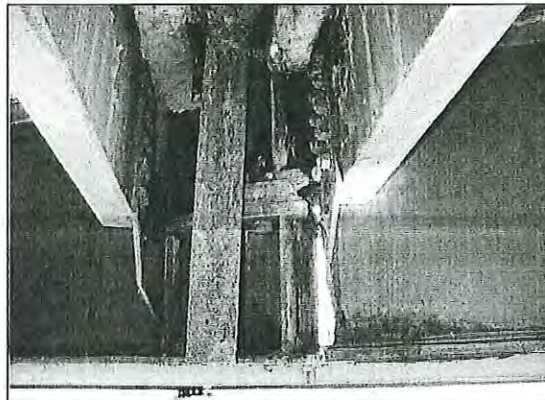
1. Repair Beam/Girder Heavy rust scale in the beams at splice
 Location: _____
 Est. Quantity _____
 Urgency of Repair Coding: Needs to be addressed

2. Repair/Replace Brg Devices Swedge bolt busted off at suspended span
 Location: _____
 Est. quantity - Each: _____
 Urgency of Repair Coding: Needs to be addressed

INSPECTOR COMMENTS: Some beams have heavy rust scale with section loss in the webs and flanges located on the ends at the suspended spans due to the leakage of the joints. A swedge bolt has busted out at beam #4 (west side) at pier #1 in the suspended span bearing and needs replacing. There is heavy rust scale in some of the other swedge bolts in both ends of the suspended span. Considerations should be given to replacing these bolts at the same time. Beams need extensive cleaning and painting at the suspended spans to deter more deterioration and stop any holes from forming.

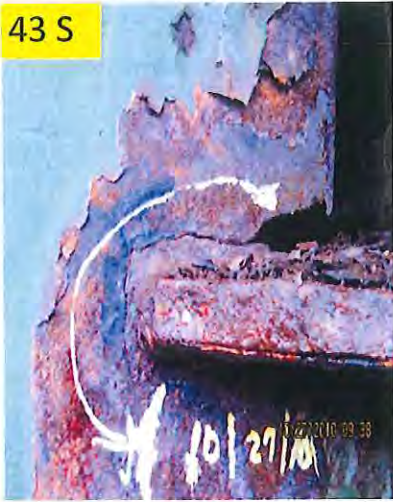
Replace all broken or bent seating bolts.
Suspended span
28 seats total to check
Critical

South Seat Area of Span No.2

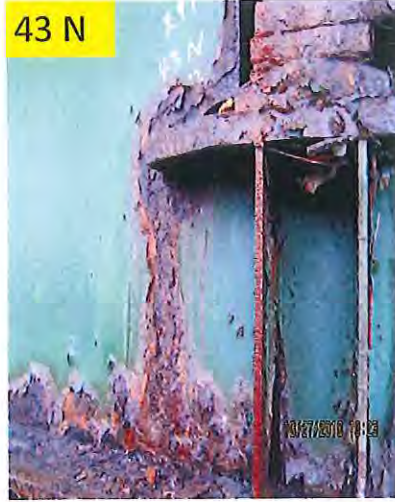
North Seat Area of Span No.2
